Gateway National Recreation Area Hurricane Sandy

Storm Damage – Sandy Hook

Storm Damage Overview – Sandy Hook

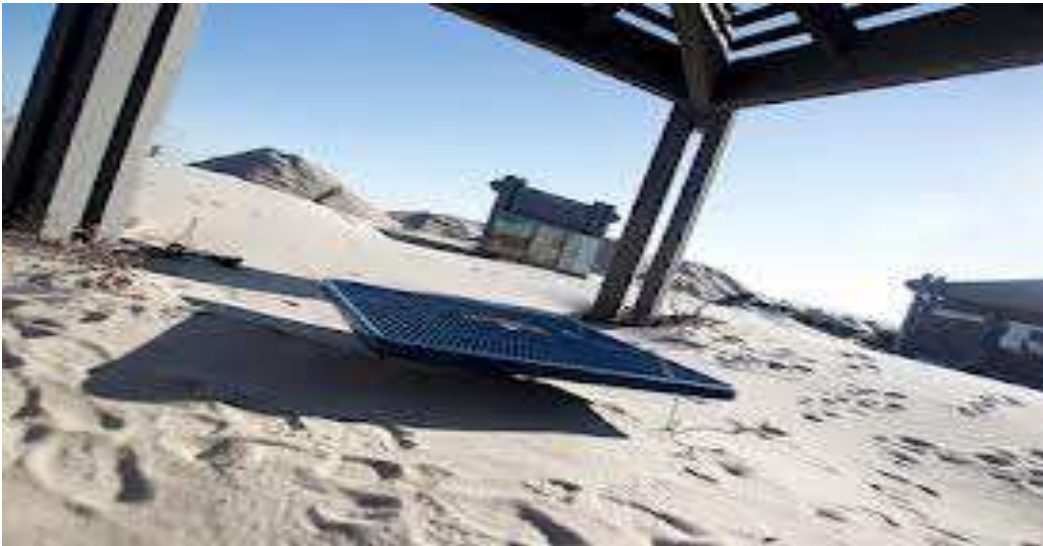
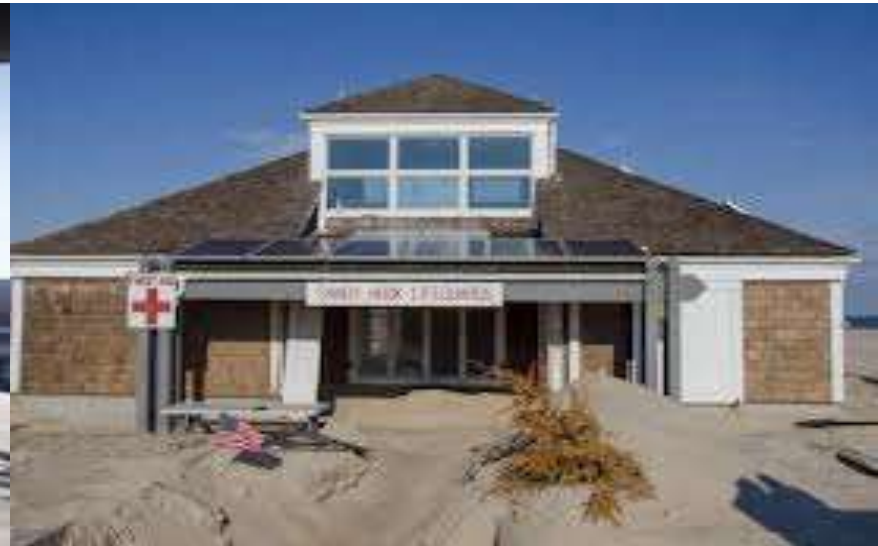
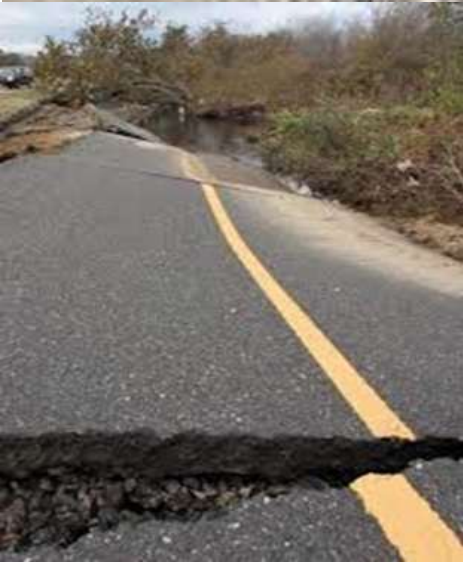
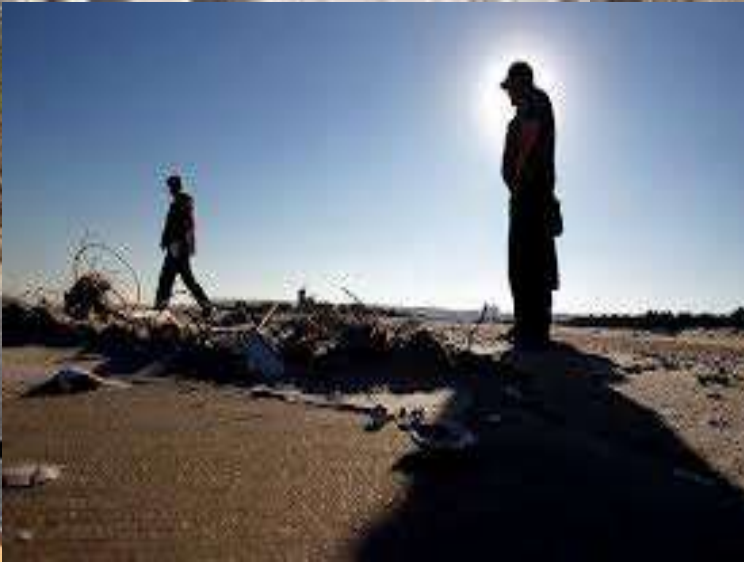
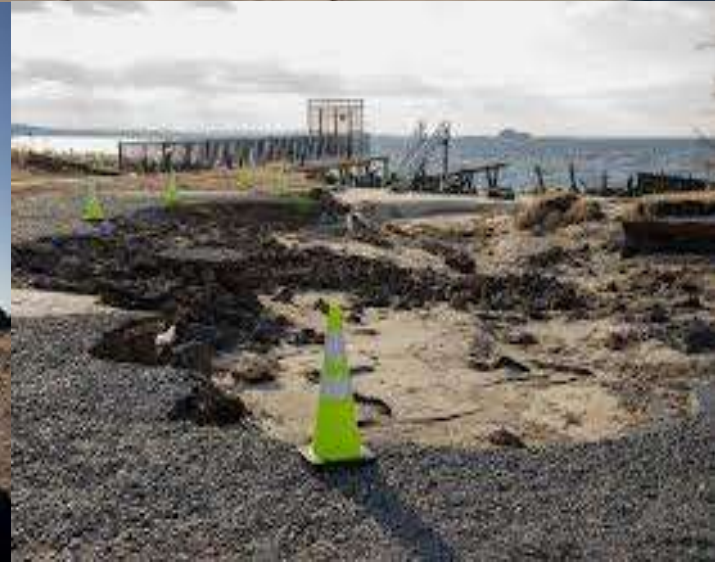
- Iconic lighthouse is in good shape and sustained no damage.
- No builds were washed away or structurally compromised by the storm surge.
- The fresh water and sewage systems were incapacitated and electricity is limited and phone service is limited to cell service.
- We lost all heavy equipment at Sandy including vehicles, emergency, beach cleaners, etc..
- All roads flooded at Sandy and many had significant sand coverage.

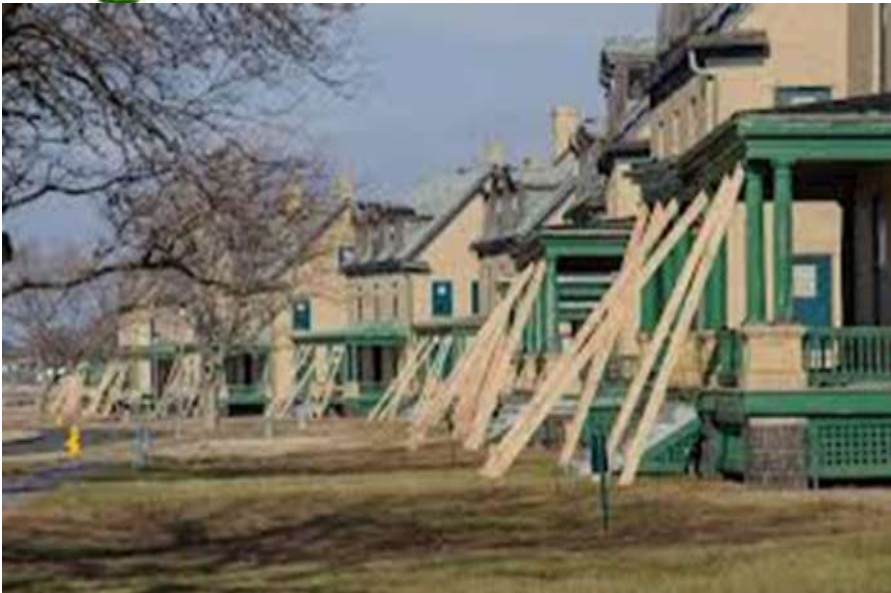
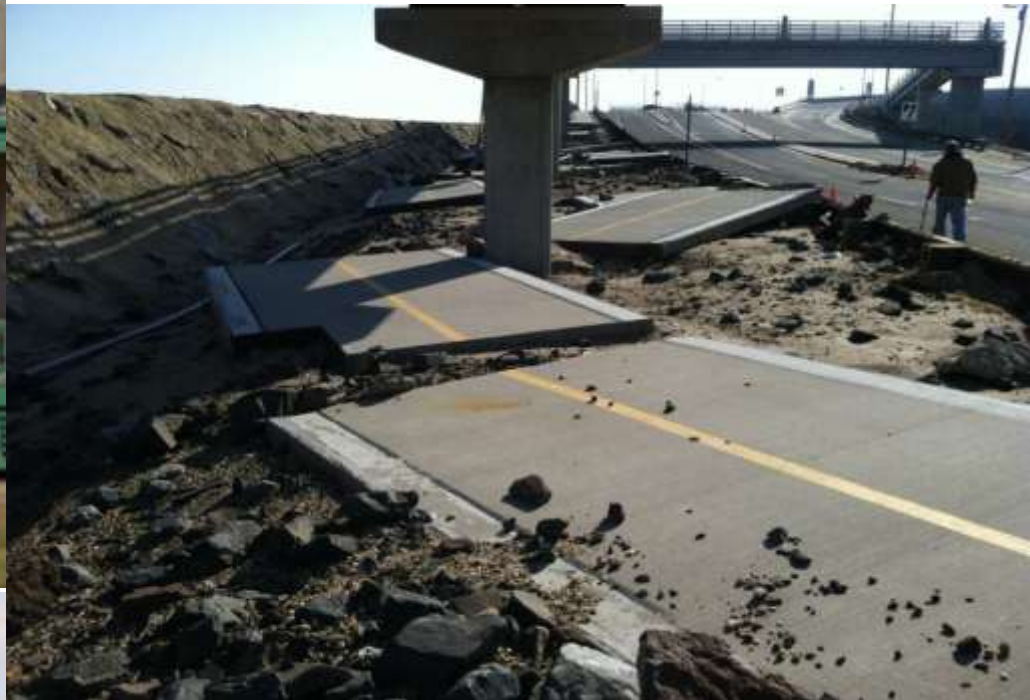
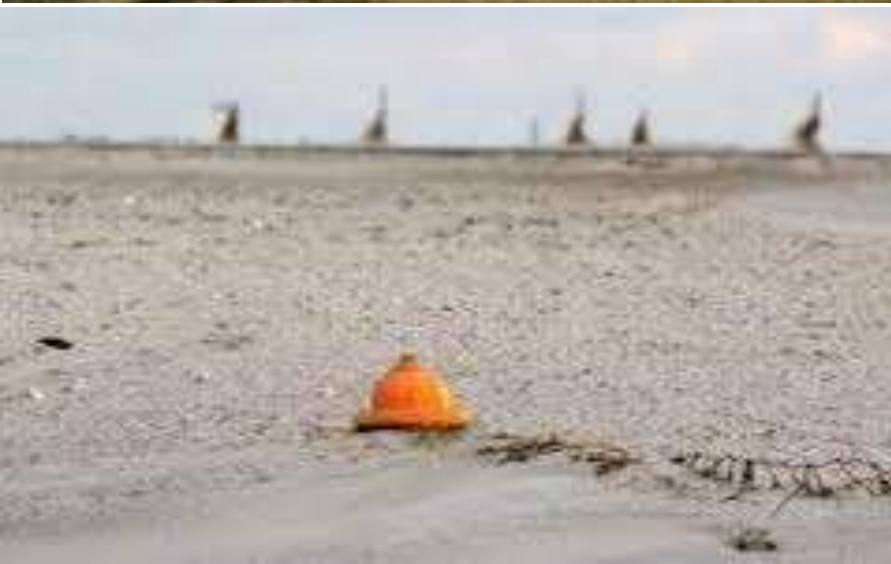
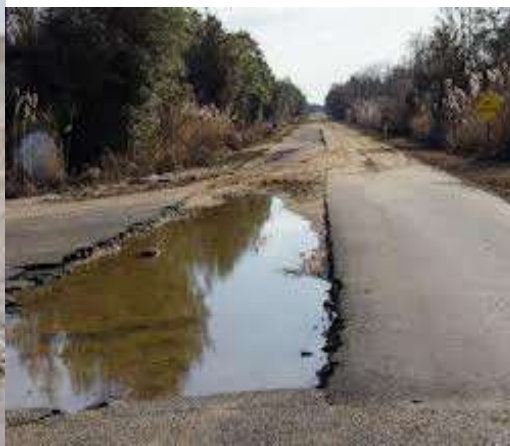
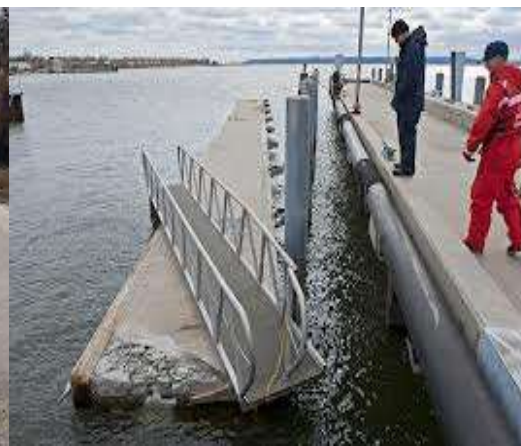
Storm Damage – Sandy Hook

- The majority of the structures had water in the basements from the storm surge or extremely high ground water levels.
- Wood porches in several Officer Row buildings have been compromised and or damaged.
- Most of the existing utility systems including heating, electric, and HVAC systems need to be replaced because they were in the basement and not elevated.

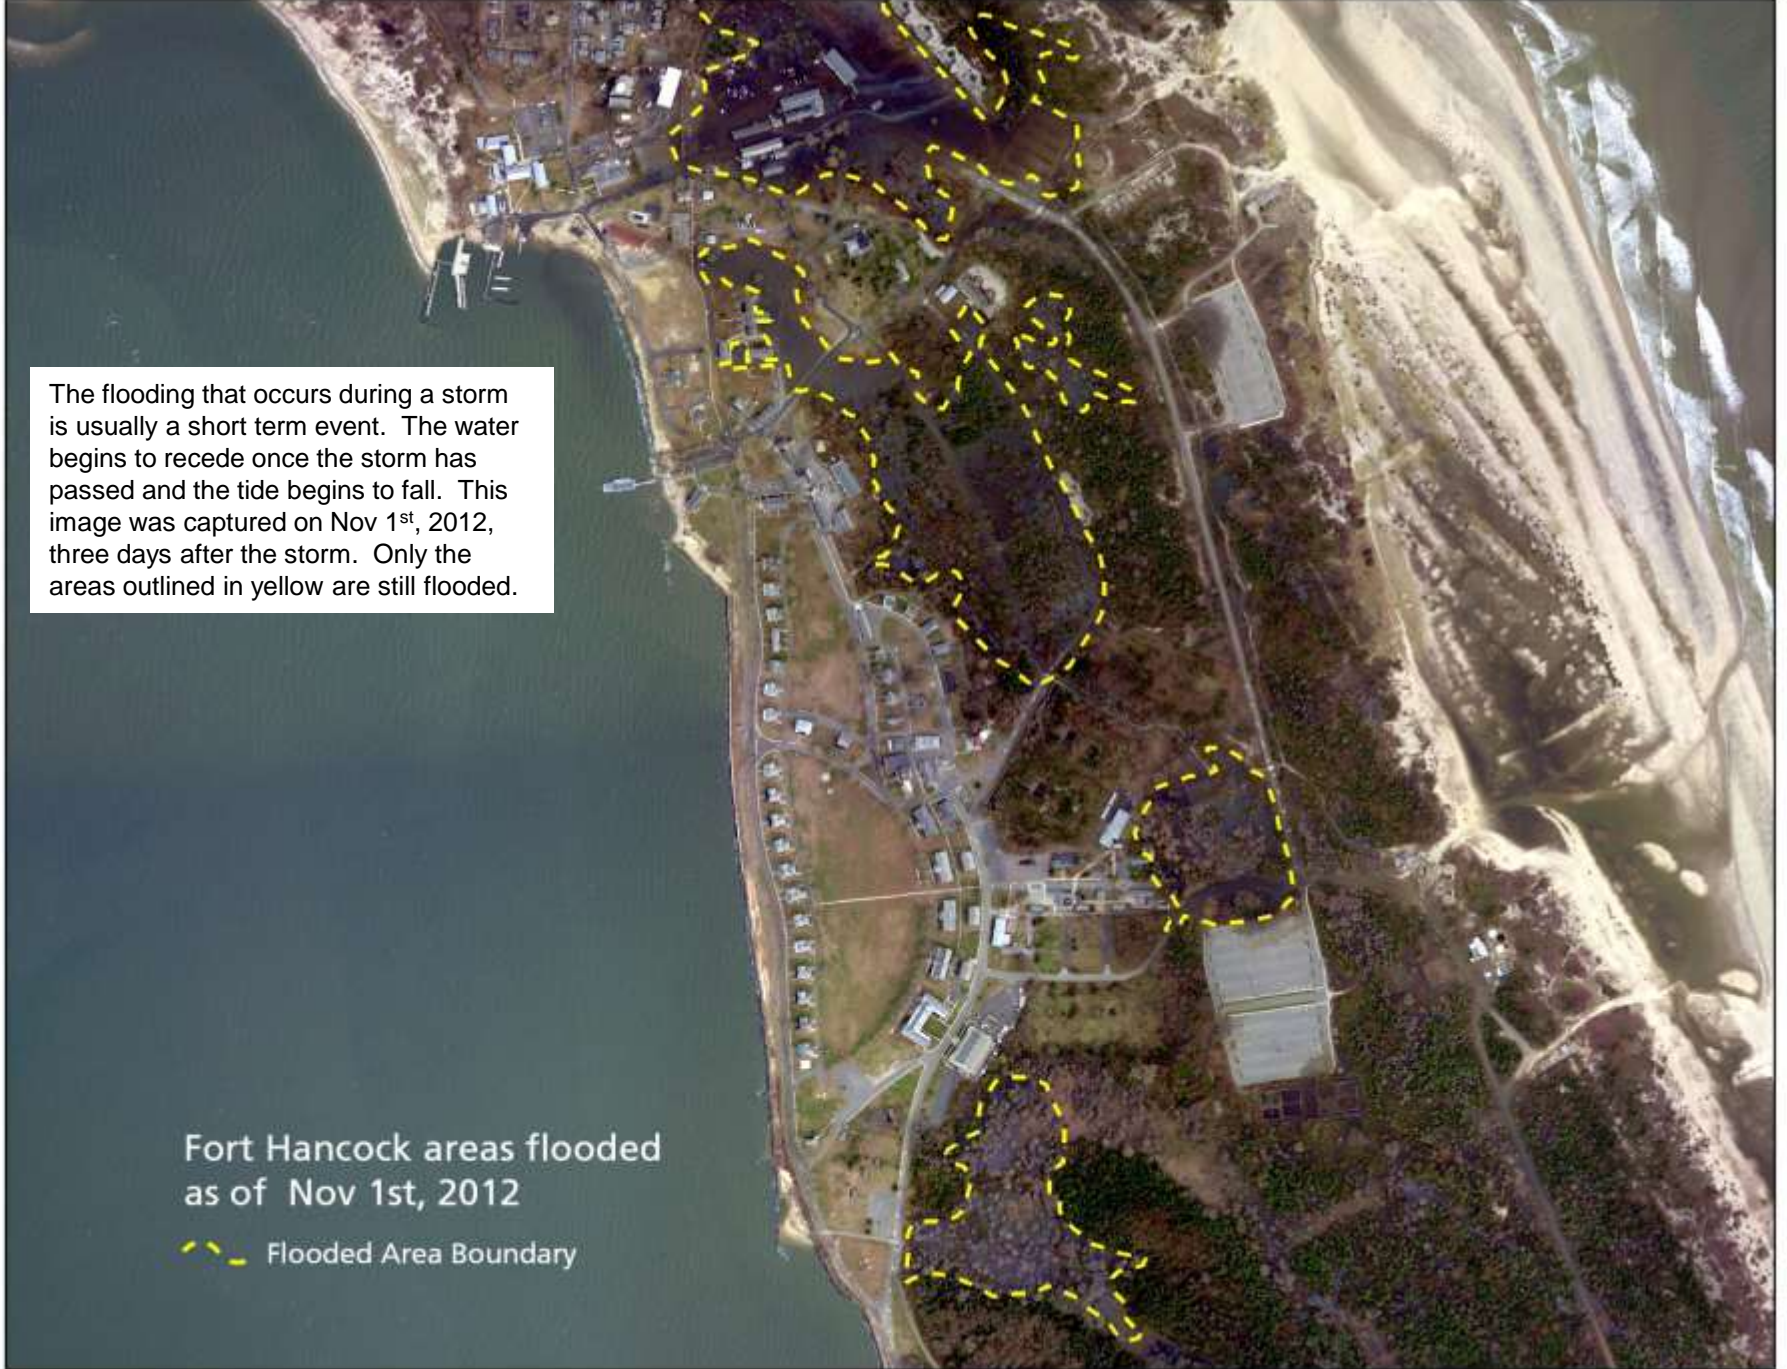
Fort Hancock areas flooded
as of Nov 1st, 2012

The flooding that occurs during a storm is usually a short term event. The water begins to recede once the storm has passed and the tide begins to fall. This image was captured on Nov 1st, 2012, three days after the storm. Only the areas outlined in yellow are still flooded.
